**Project:** Dzero Electrical Support

**Doc. No:** A1050613A

**Subject:** Fusing of Calorimeter Pre-amplifier low voltage wiring

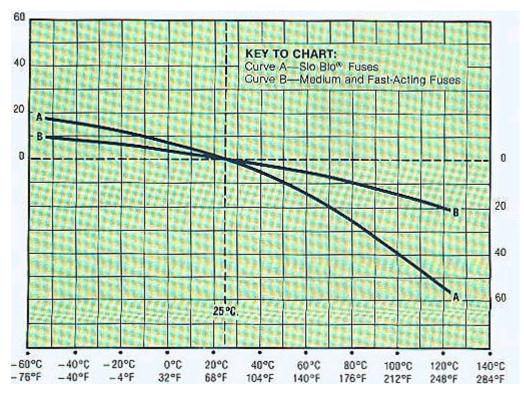
Figure 3

The speculation given is not supported by manufacturer's data sheets. The more likely explanation is a reduction in fuse lifetime from heating, either of the fuseholder or from IR drop in the wiring itself. A typical derating curve for fuses of the fast-blow and slow-blow type is given in Figure 3. Although most people assume that slo-blo fuses are preferred, they do have significantly larger temperature sensitivity.

At this temperature rise a slow-blow fuse may be derated as much as 15%, meaning that the 20A fuse actually acts like a 17A fuse. This is so close to the actual measured currents of the supply that it may explain the consistent fuse failure rate. Use of a fast-blow 20A fuse would result in a derated value of 19 Amps. This simple change may possibly solve the problem of consistent fuse loss without having to re-examine the safety aspects.

- 3. Temperature rise estimates suggest that the use of slo-blo fuses is a mistake and that, if usable, fast-blow fuses will provide greater margin against heat derating.
